DCN Next Generation 4.71 Release Notes

DCN Next Generation Release 4.71

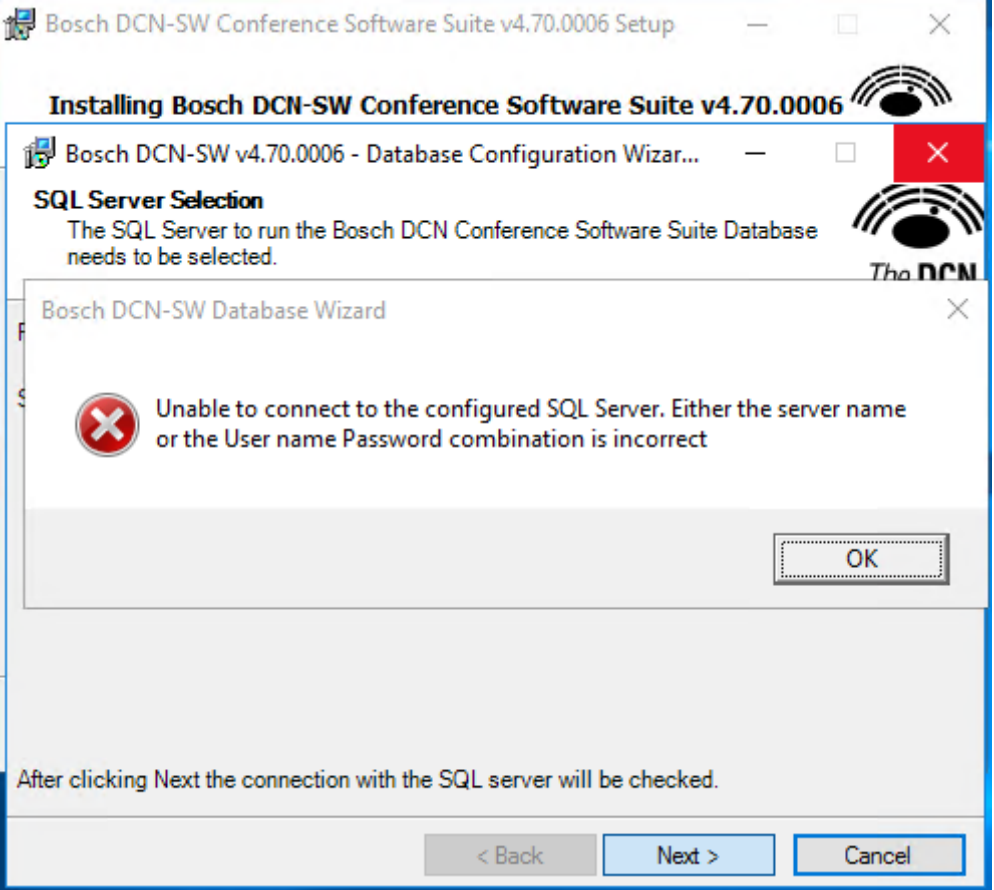
<p>The screenshot shows a multi-step installation wizard. The current step is 'SQL Server Selection'. The text reads: 'The SQL Server to run the Bosch DCN Conference Software Suite Database needs to be selected.' Below this, a smaller error dialog box is open with a red 'X' icon and the message: 'Unable to connect to the configured SQL Server. Either the server name or the User name Password combination is incorrect'. At the bottom of the wizard, there are buttons for '< Back', 'Next >', and 'Cancel'. An 'OK' button is visible on the error dialog box.</p> <p>Via the OK button and the browse option you can select the already available database server.</p>

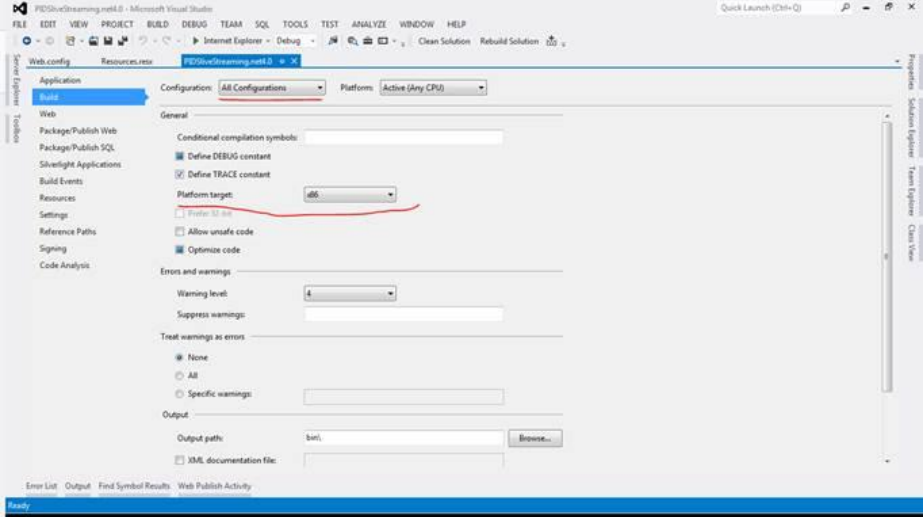
Reference	What
<p>DCN-SWAPI</p>	<p>Using the API for normal or ASP.NET environments.</p> <p>Prerequisite: Only x86 (32 bit environment) target build platforms are supported for projects.</p>

<p>The DCN-SWAPI requires to load the “Bosch.Dcn.Ecpc.Client.Logic.dll.config” file from the current folder.</p> <p>If the current folder differs from the .EXE location then the “Bosch.Dcn.Ecpc.Client.Logic.dll.config”file has to be copied to the new current folder.</p> <p>This current folder is different depending on the environment and running on 64 bit Windows:</p> <ul style="list-style-type: none"> • Normal .EXE : The location of the executable • .EXE running as service : %SystemRoot%\SysWOW64 • ASP.NET app in IISExpress : %ProgramFiles(x86)%IIS Express • ASP.NET app in IIS : %SystemRoot%\SysWOW64\inetsrv <p>Note: Applications built on x64 platform are not supported</p>
<p>DCN-SW</p>	<p>When installing DCN-SW on a Windows 7 PC you might get the following notification:</p>

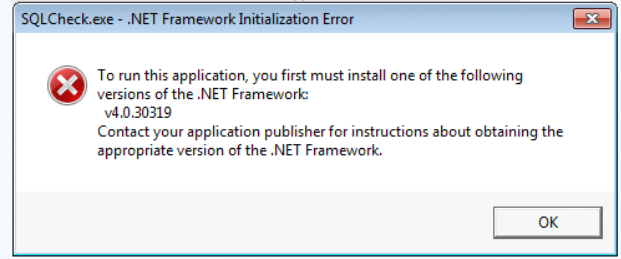
<p>This is because within the time installer checks for framework, SQLServer installation starts which prompt for the framework installation. Please press OK, after this the framework will be installed from the DCN-SW installer and DCN-SW installation will install successful.</p>
