DCN Next Generation 4.70 Release Notes

DCN Next Generation Release 4.70

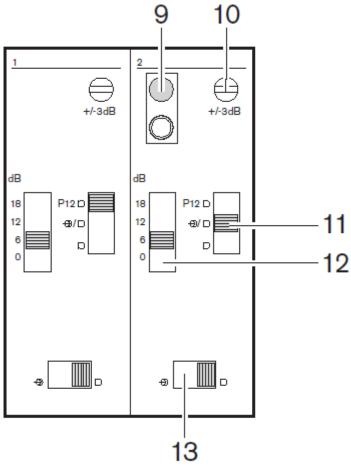
Chapter 7.13 DCN-DDI Dual Delegate Interface

- 9. De-init switch Erases the address of the dual delegate interface (refer to Initialization, page 183). The red LED adjacent to the de-init switch comes on when the dual delegate interface does not have an address.
- 10. Input adjustment potentiometer Adjusts the sensitivity of the audio input.
- 11. Input type switch Sets the type of audio input.
 - Upper Balanced signal with phantom power
 - Center Balanced signal without phantom power
 - Lower Unbalanced signal*
- 12. Input adjustment switch Sets the sensitivity of the audio input.
- 13. Signal level switch Sets the signal level of the audio input.
 - Left Line level signal Right Microphone signal*
